## Site Inspection Report Summary

**Property Address:** 6231 PA-88 Finleyville, PA 15332

**Inspection Date:** 06/10/2020

## **Photo Report of Koteles Garage**

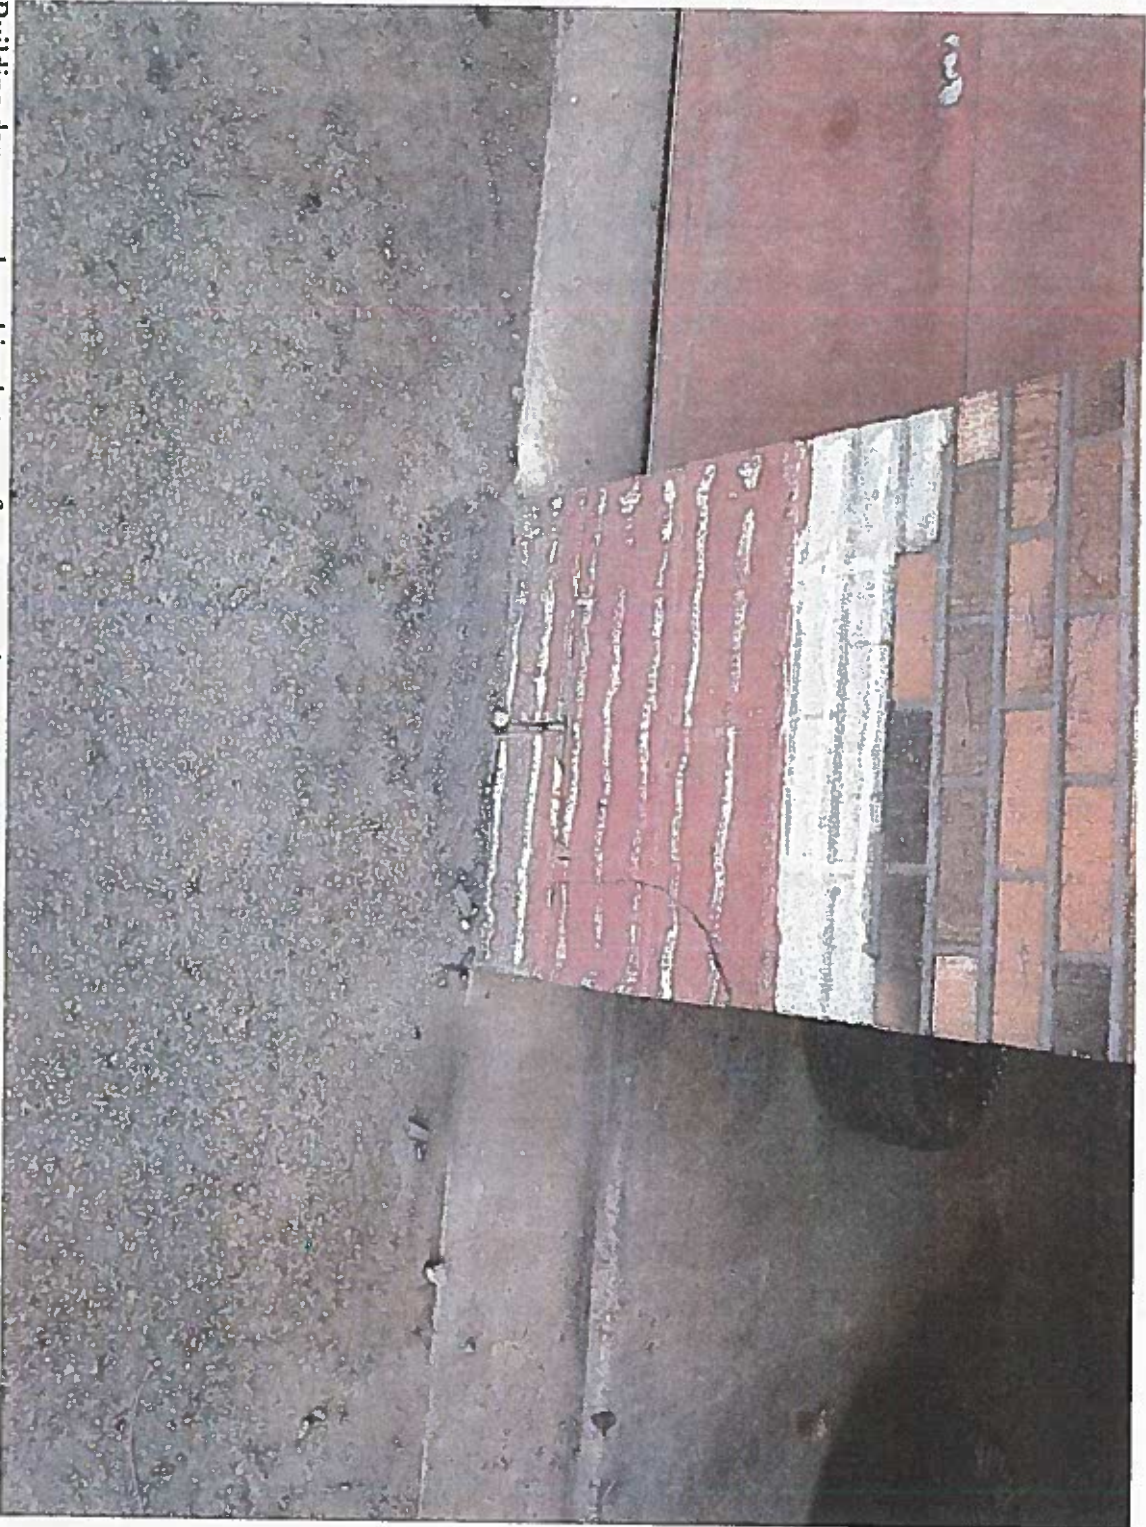
Building damage and cracking between front garage bays.

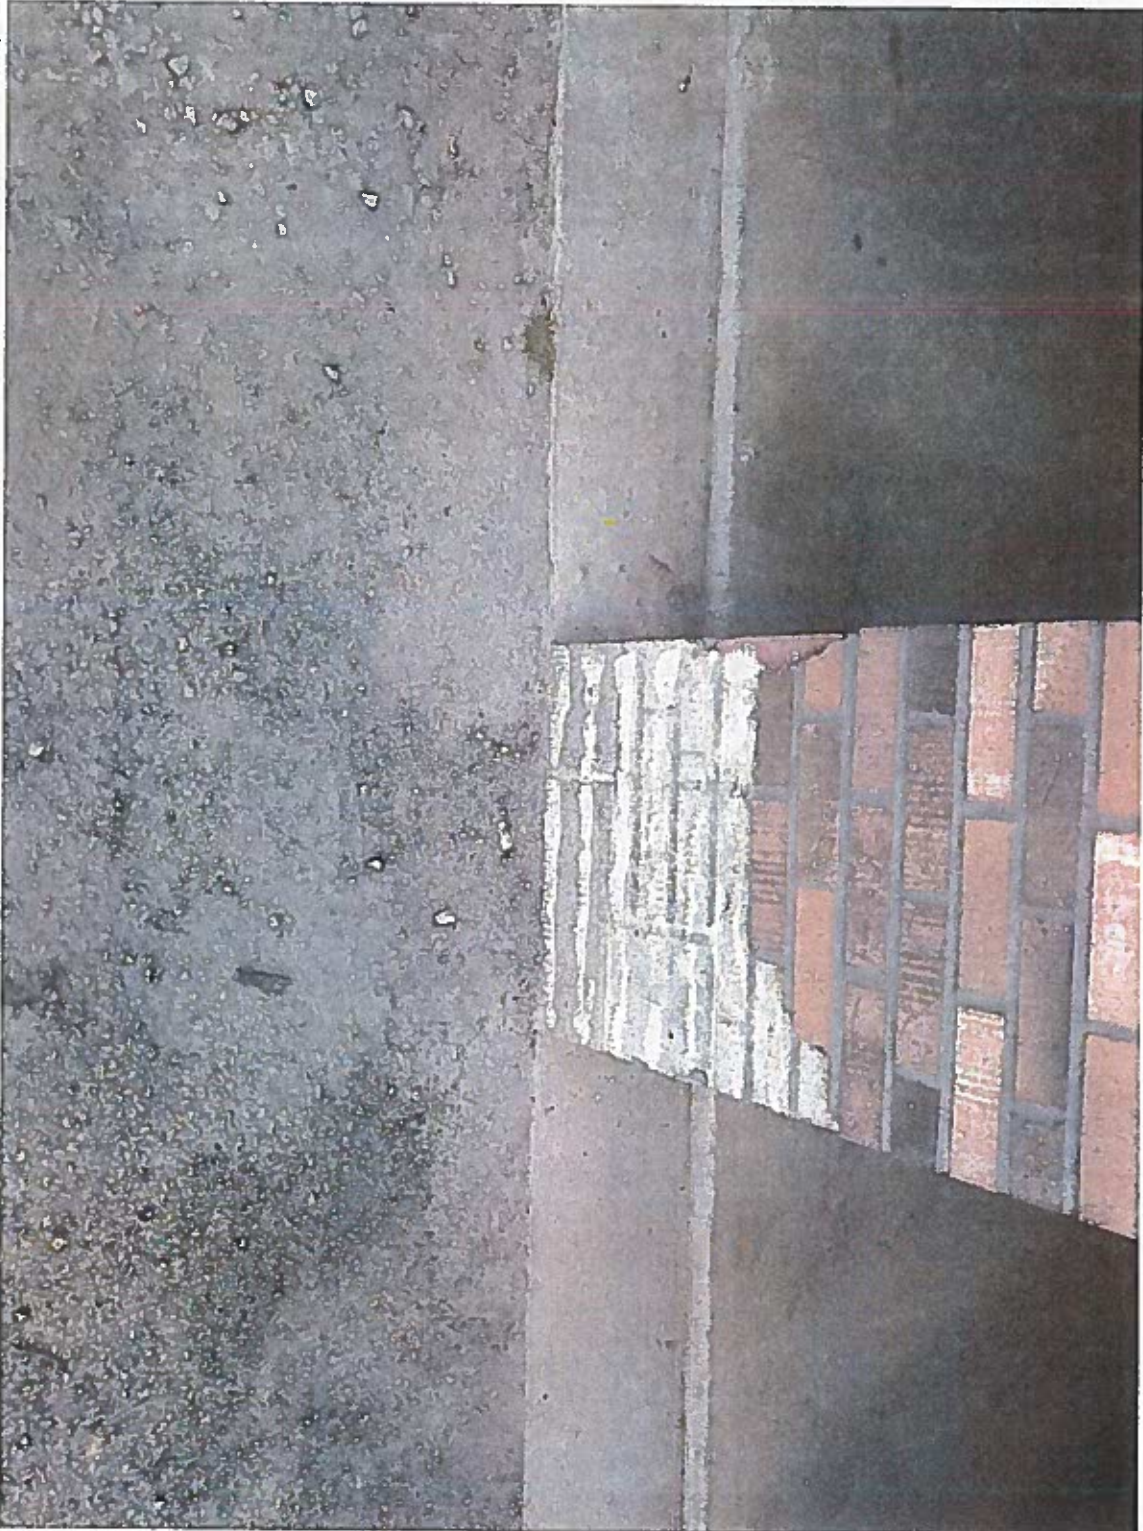
Building damage and cracking between front garage bays.

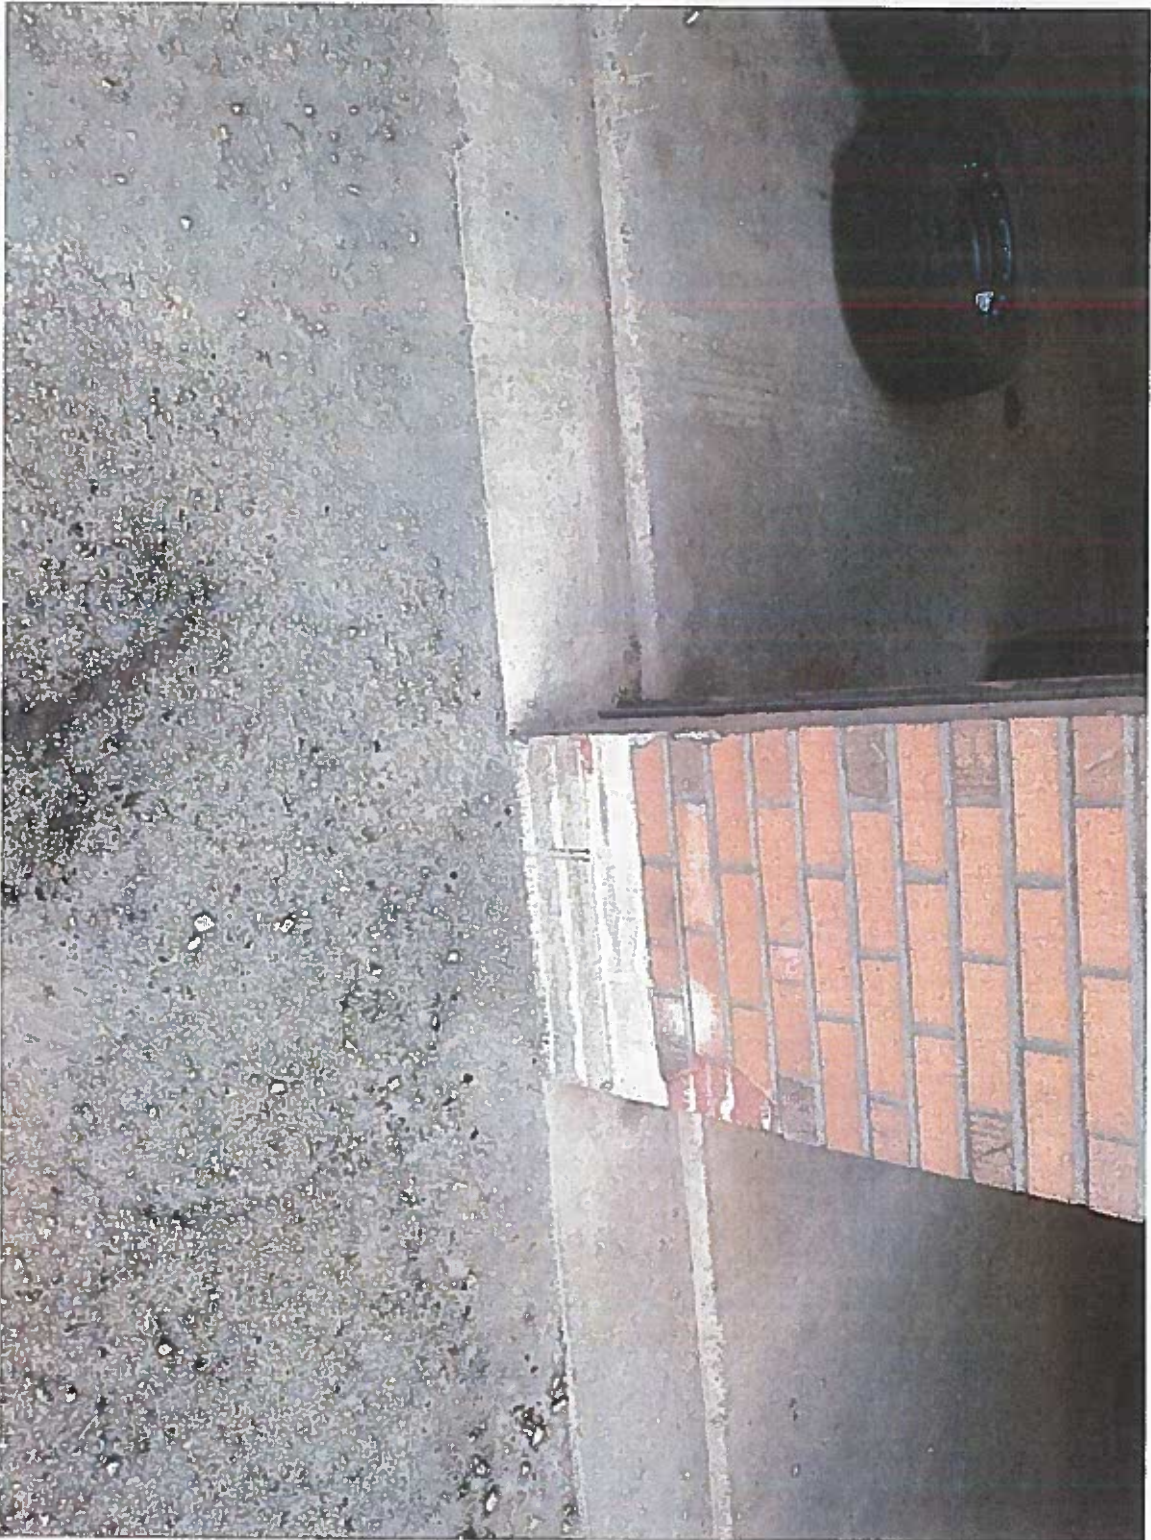
Building damage and cracking between front garage bays.

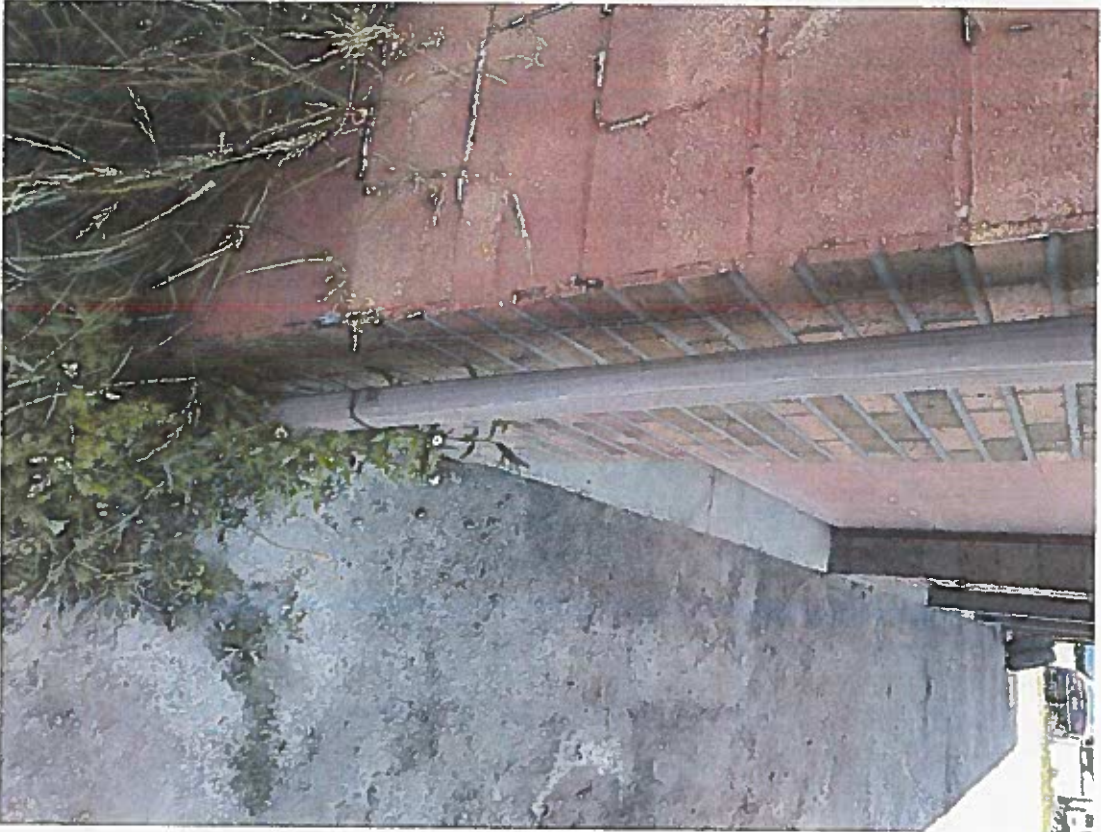
Roof downspout is unsecured from the building. There is wall damage and pavement cracking in front of garage doors.

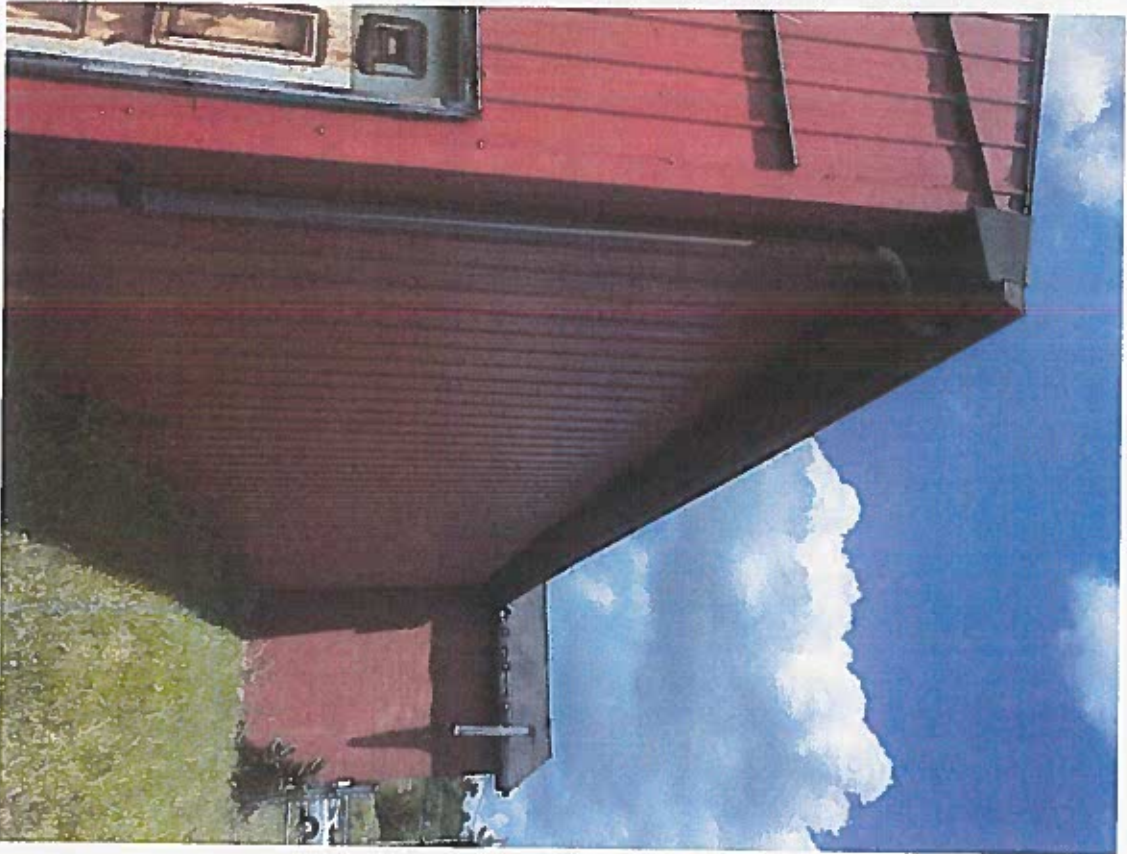
Properly secured downspout on rear of building. However, note the uncut grass and weeds near building.

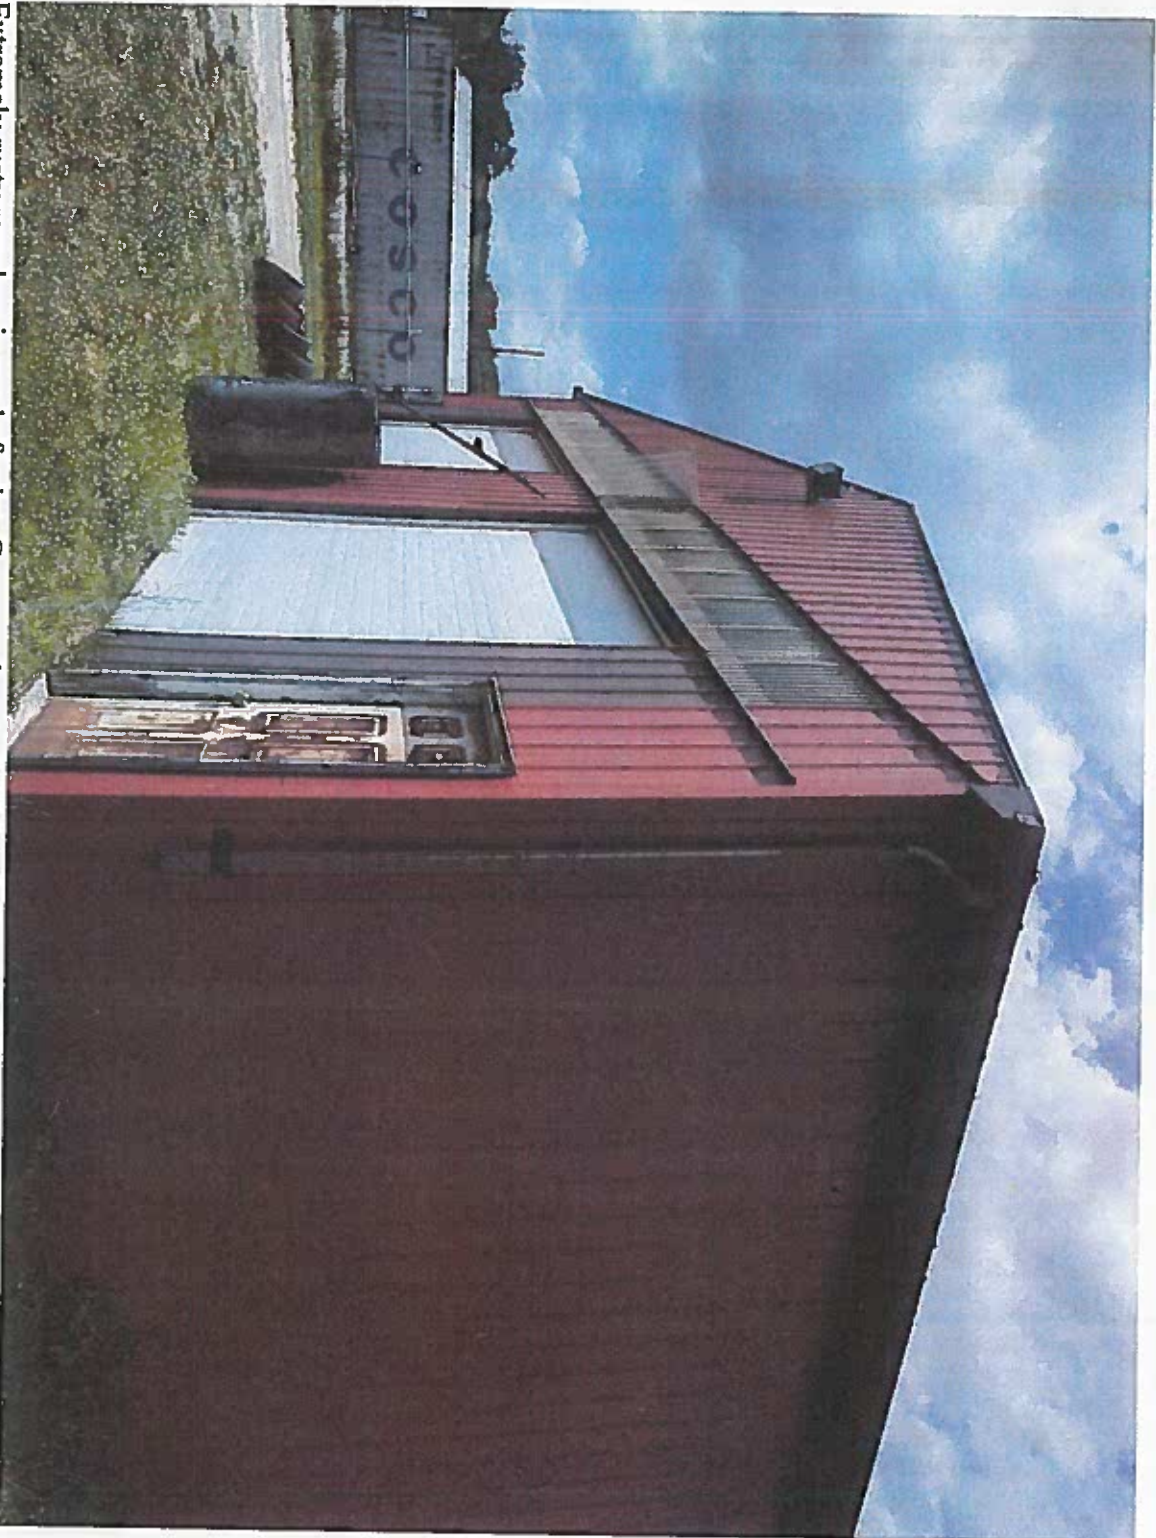
Extremely rusty rear door in need of paint. Grass needs cut. Additional views of trim pulling away above rear garage doors.

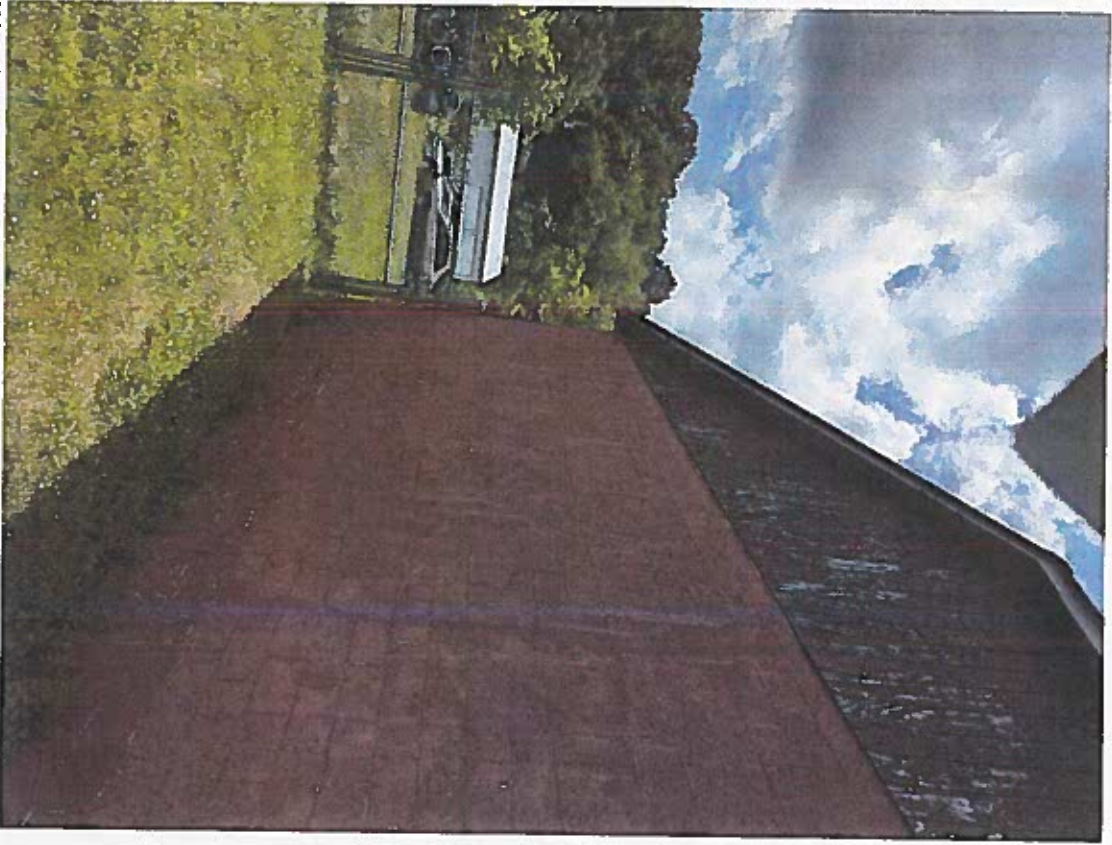
Wooden roof panels are in need of painting.

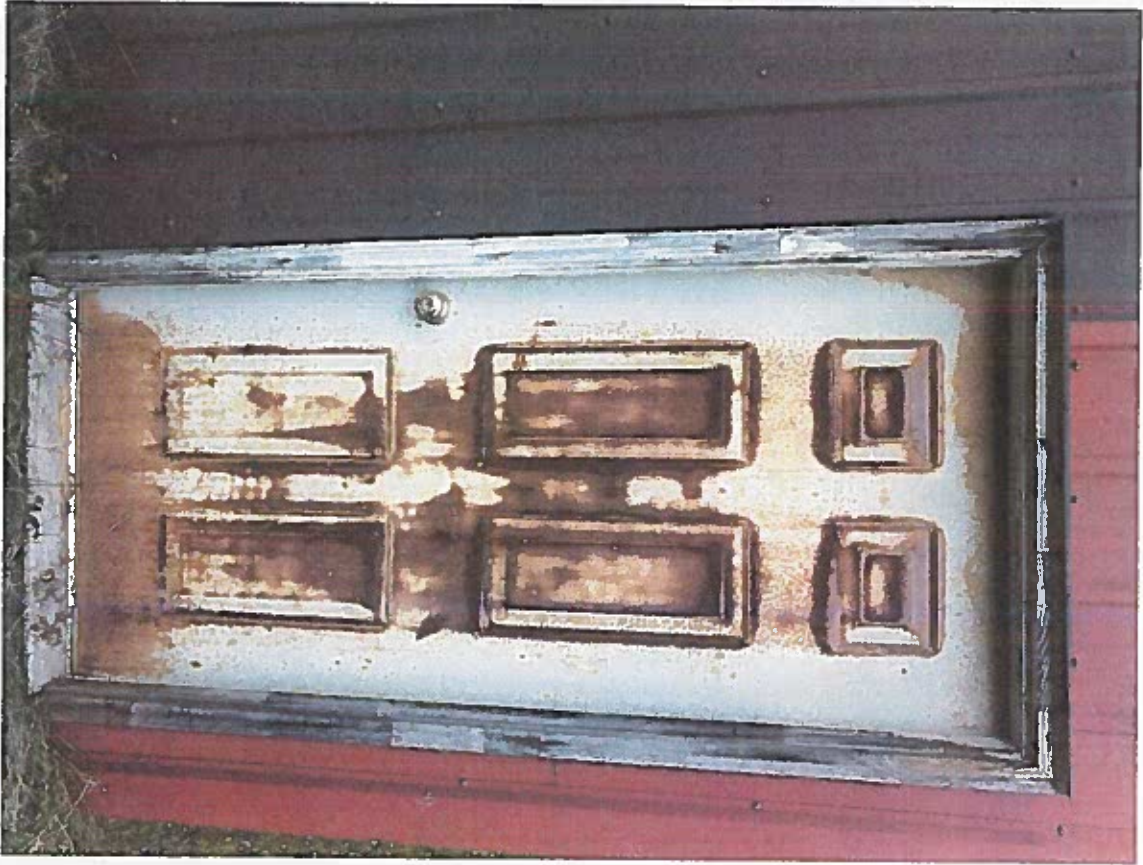
Rusty door. Unpainted trim.

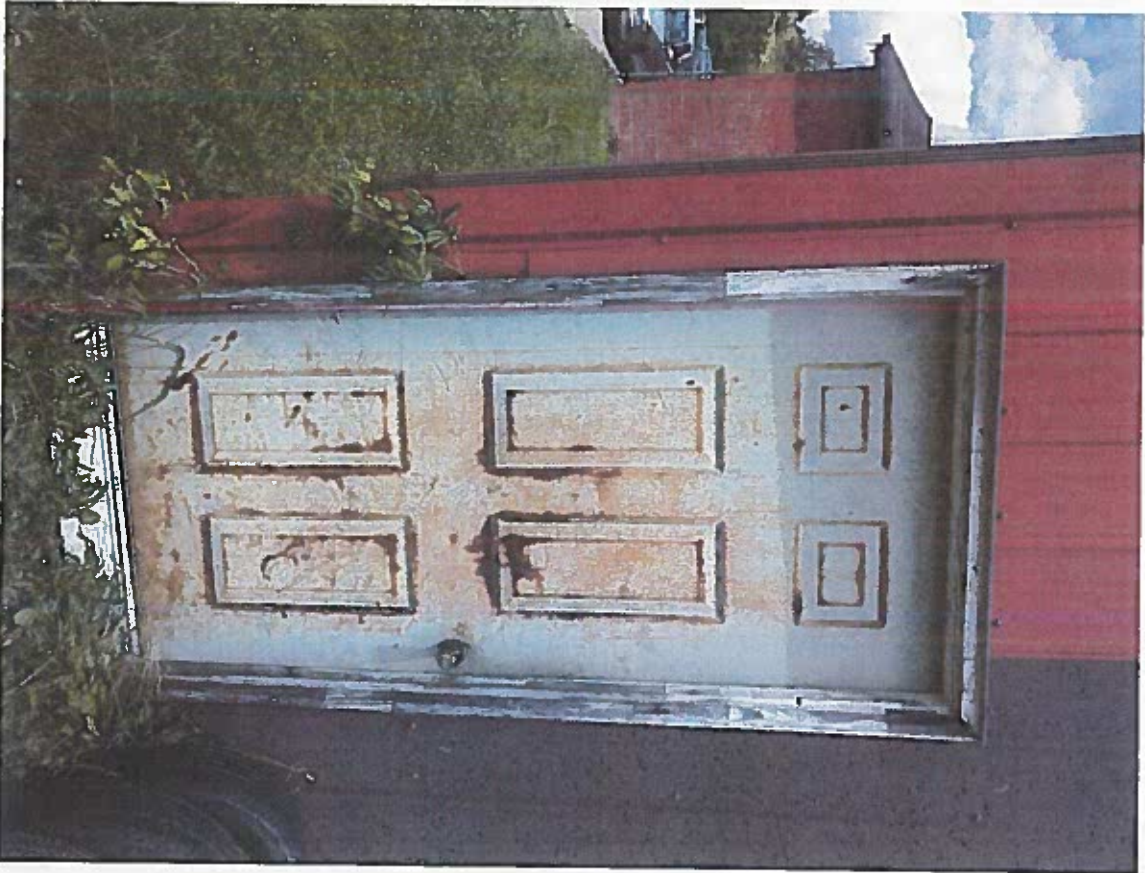
Rusty door, unpainted trim, plants growing under trim.

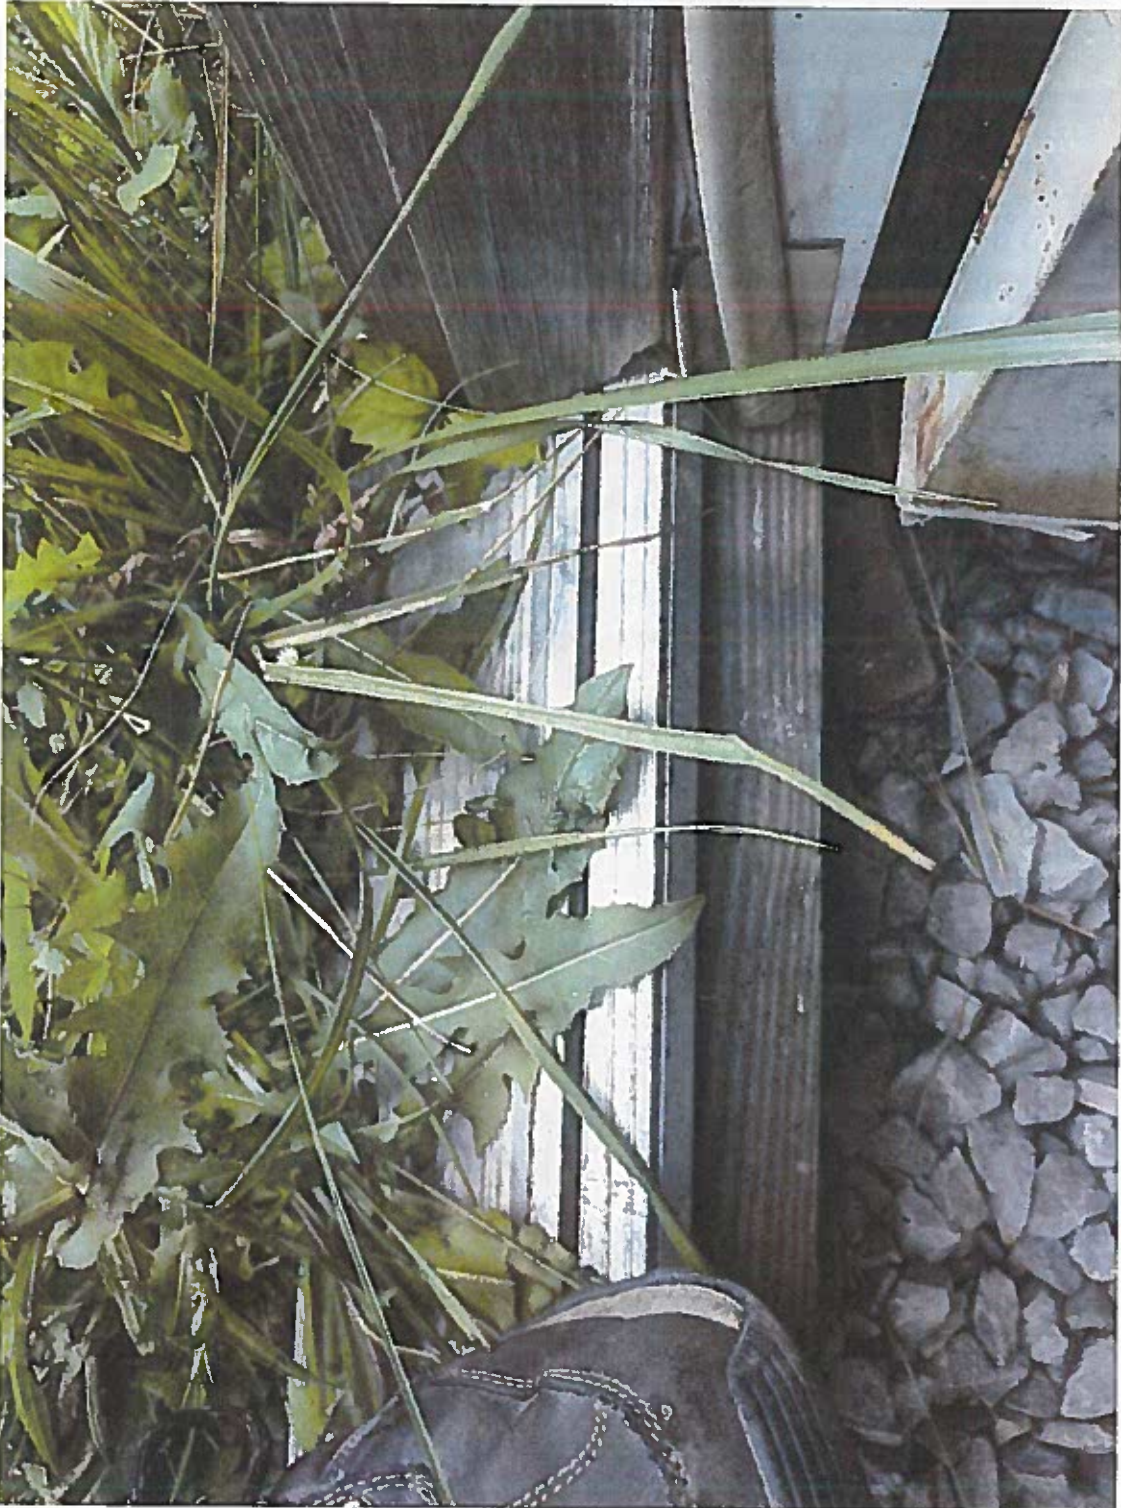
Damaged lower door plate view #1

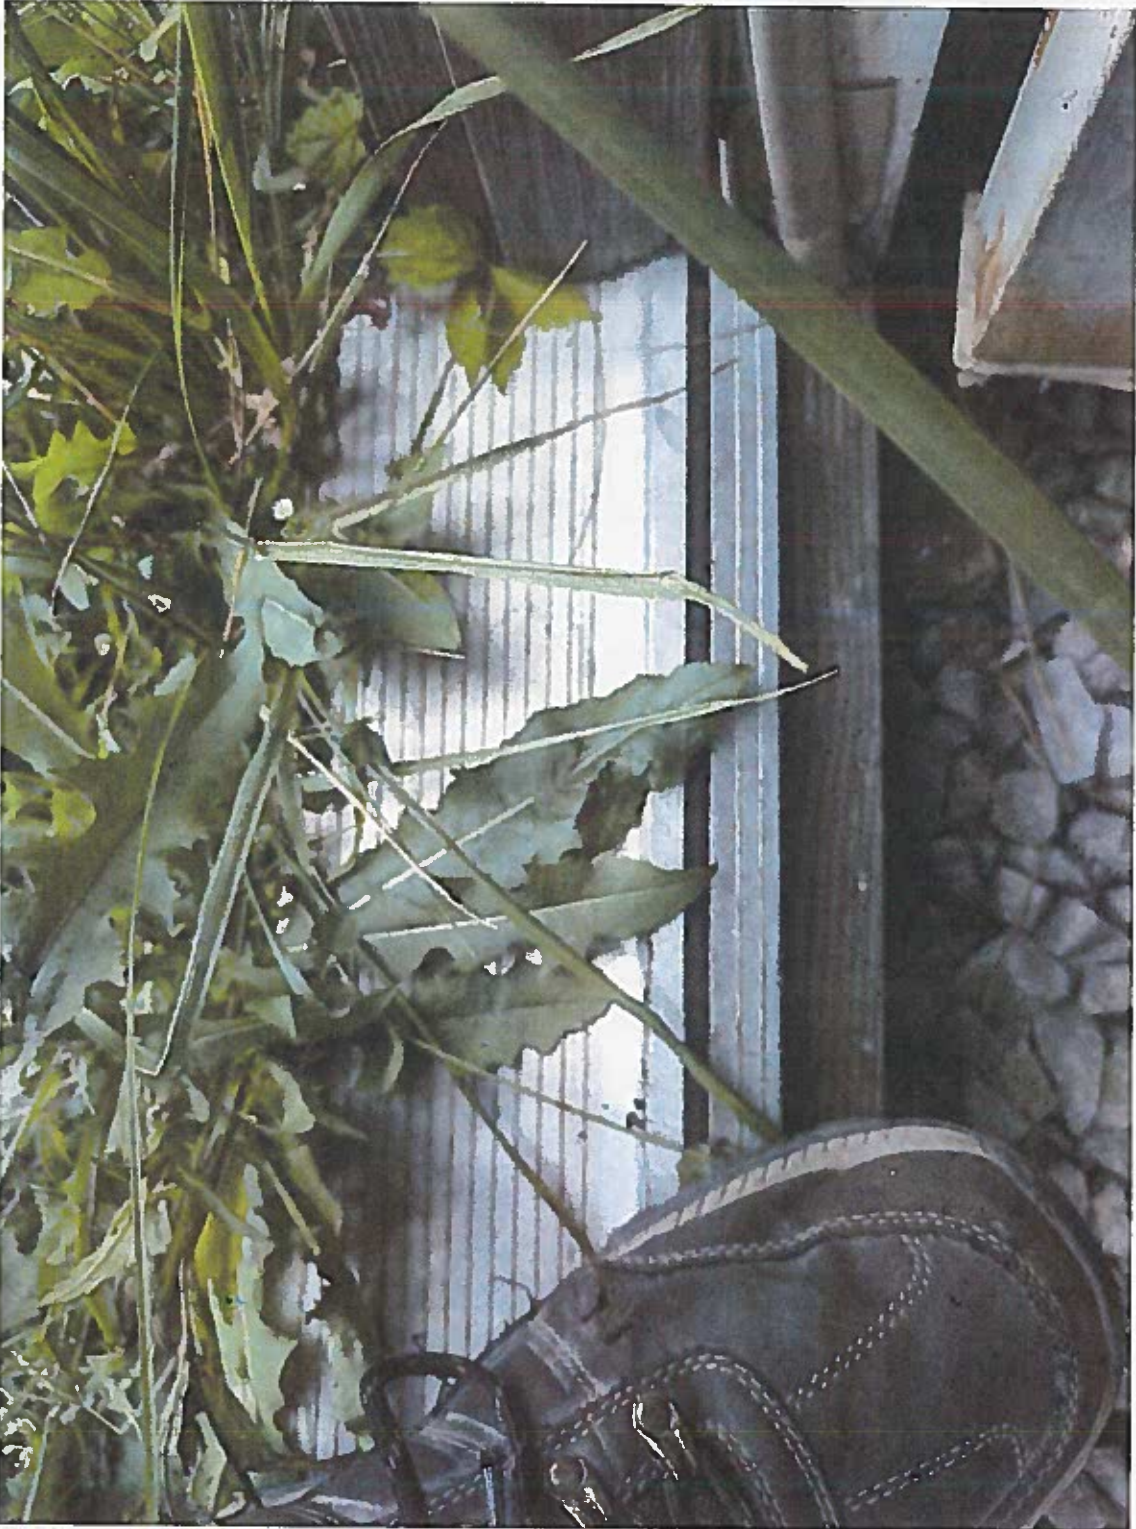
Damaged lower door plate view #2

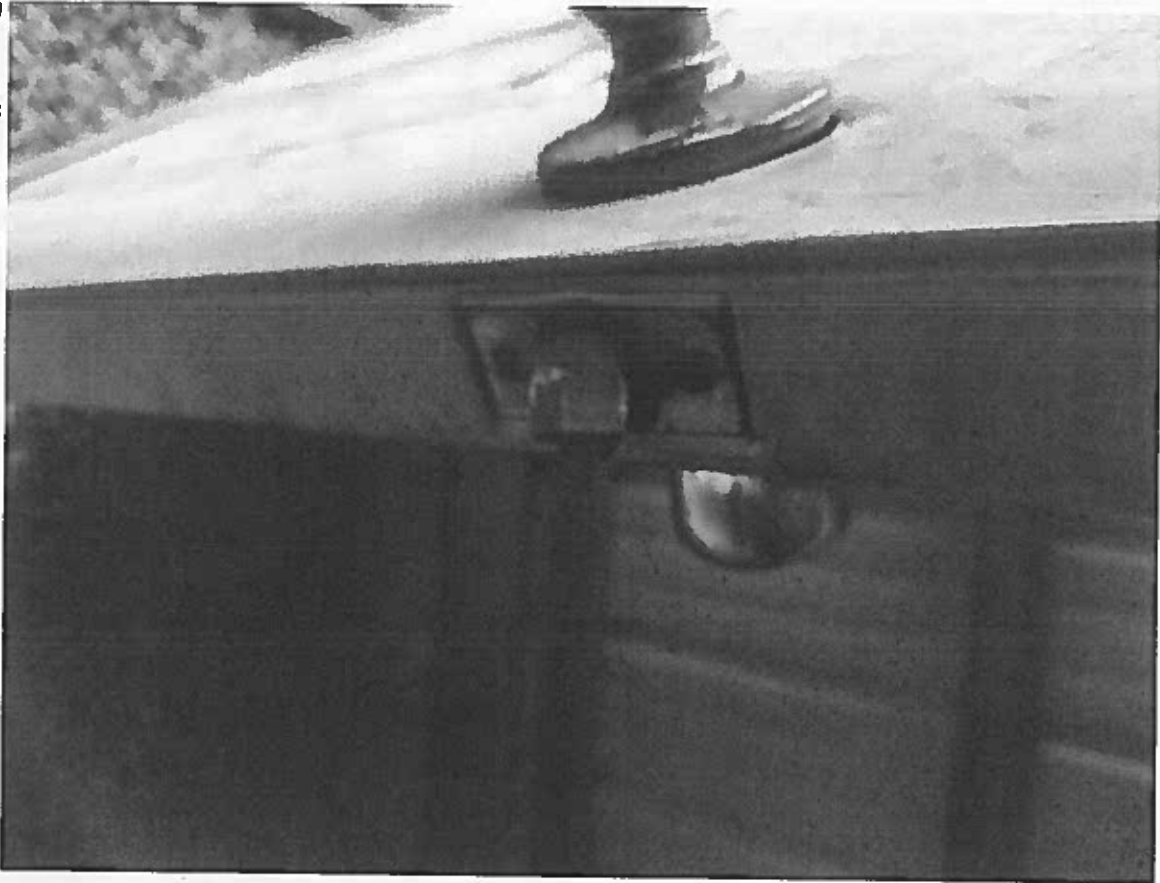
Door striker plate damage

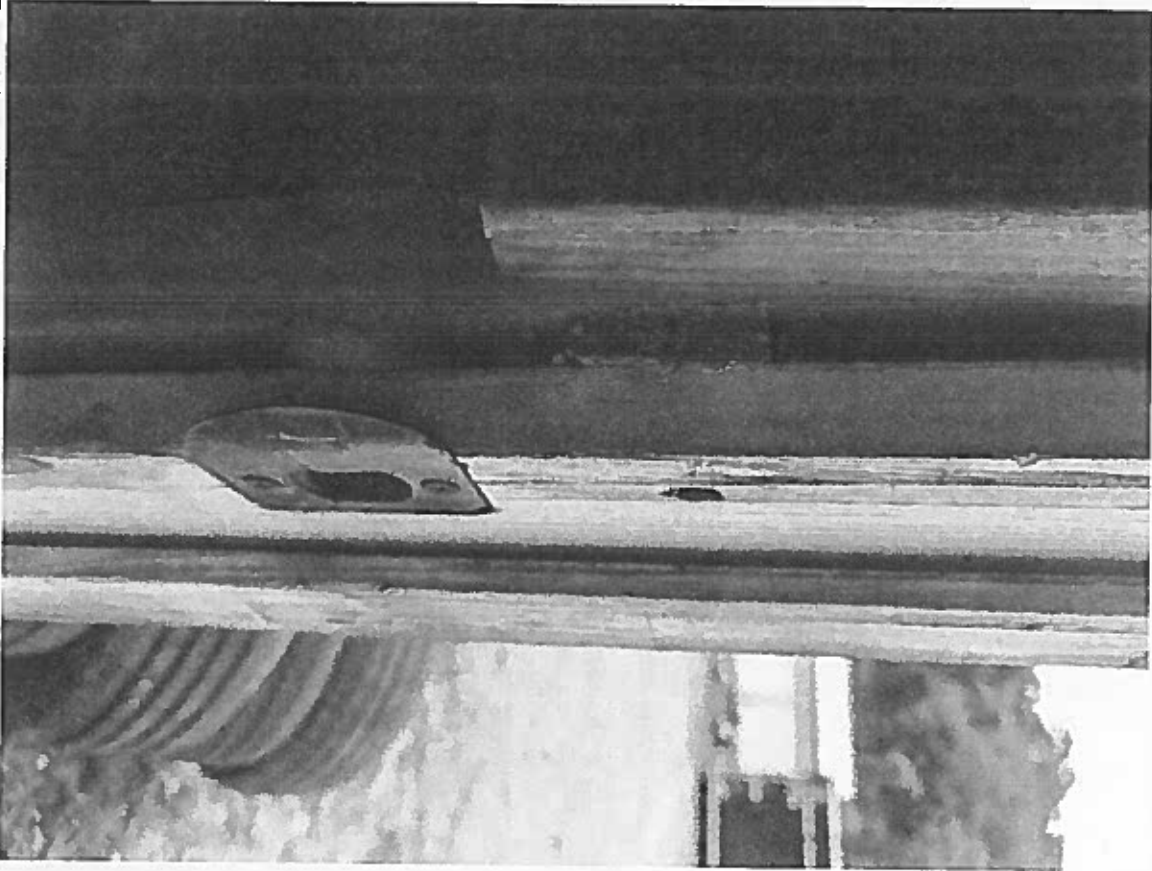
Bent / damaged wood around door frame.

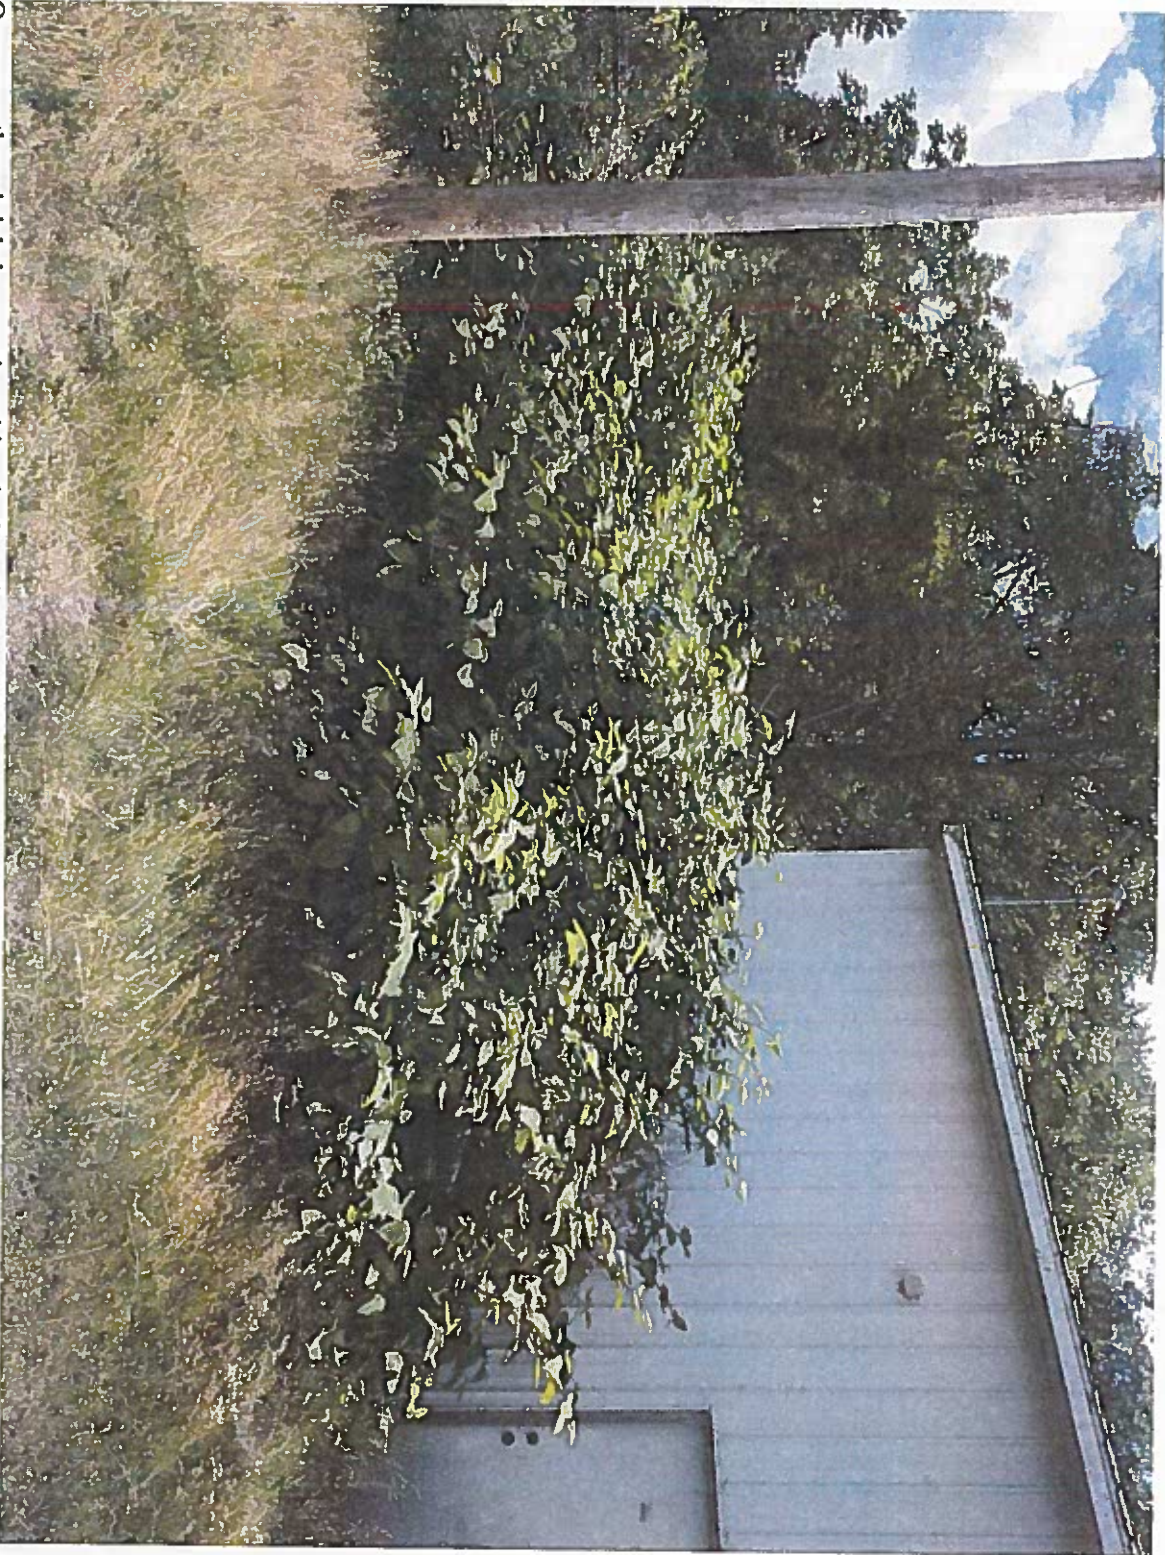
Overgrowth and debris near the white shed on the rear of the property.

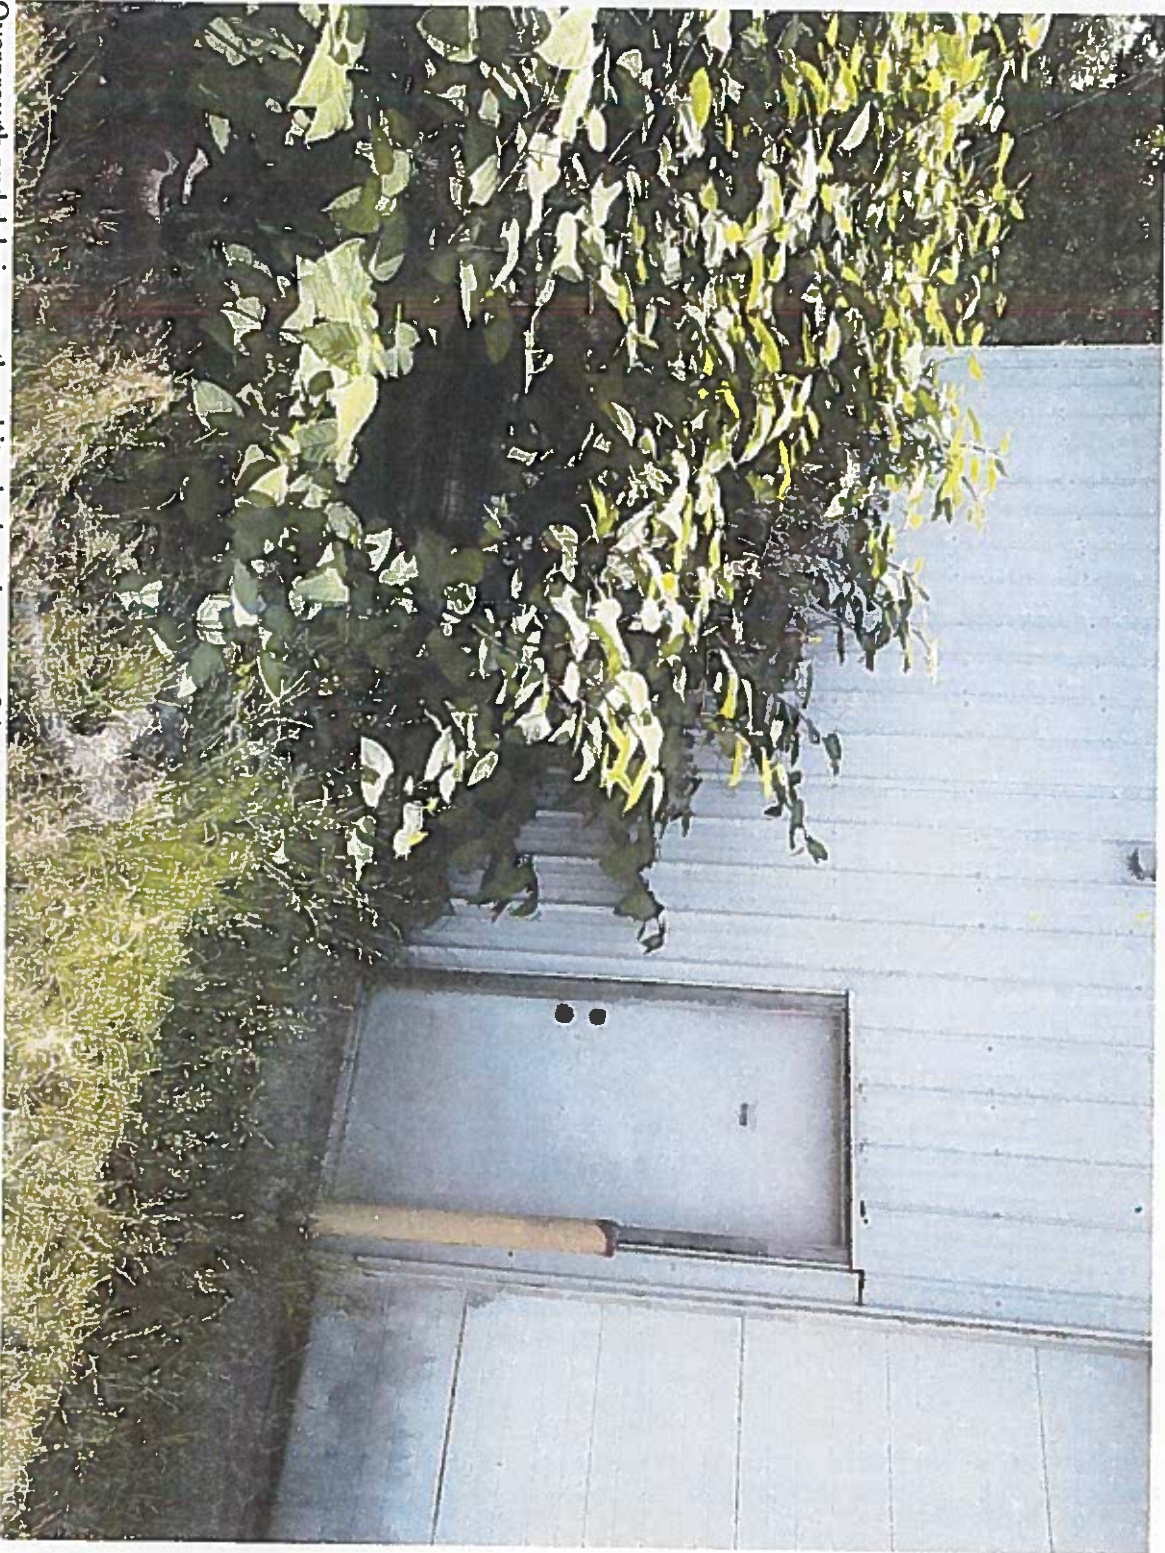
Overgrowth and debris near the white shed on the rear of the property. Notice the rear door condition.

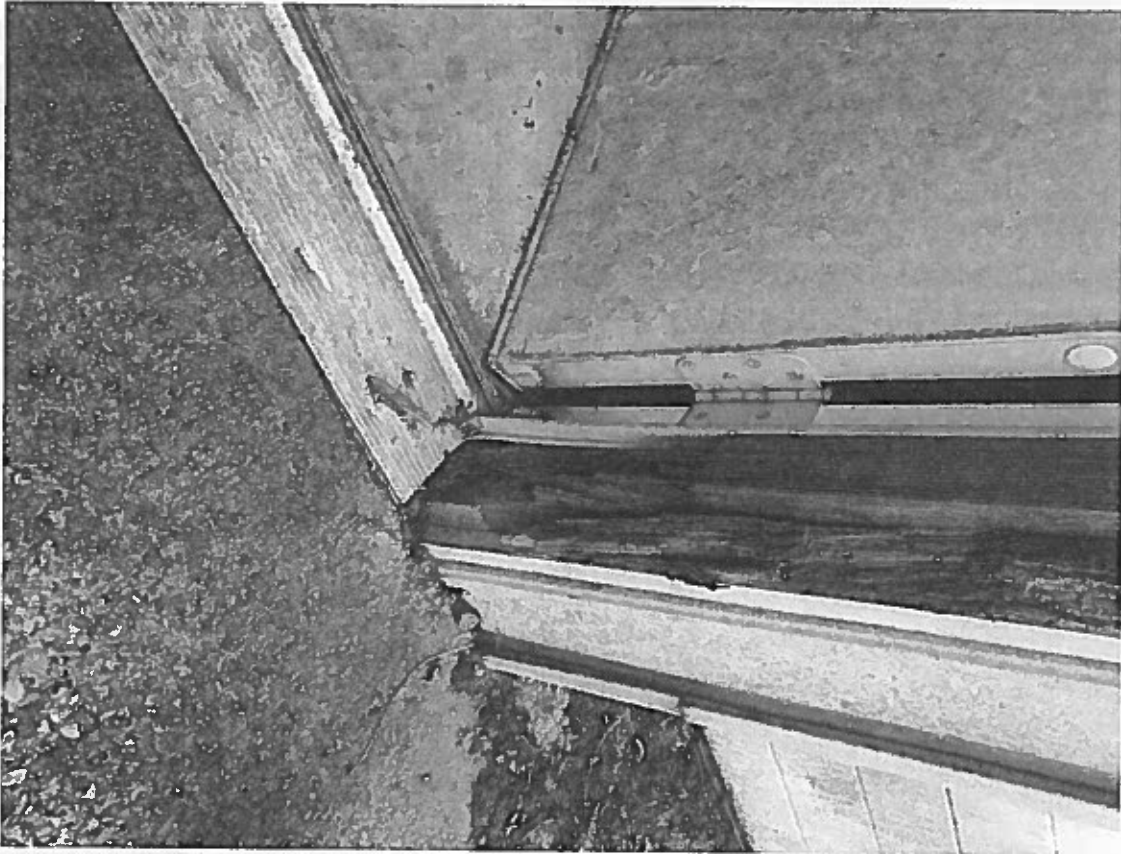
Rotting wood located around rear wooden door.

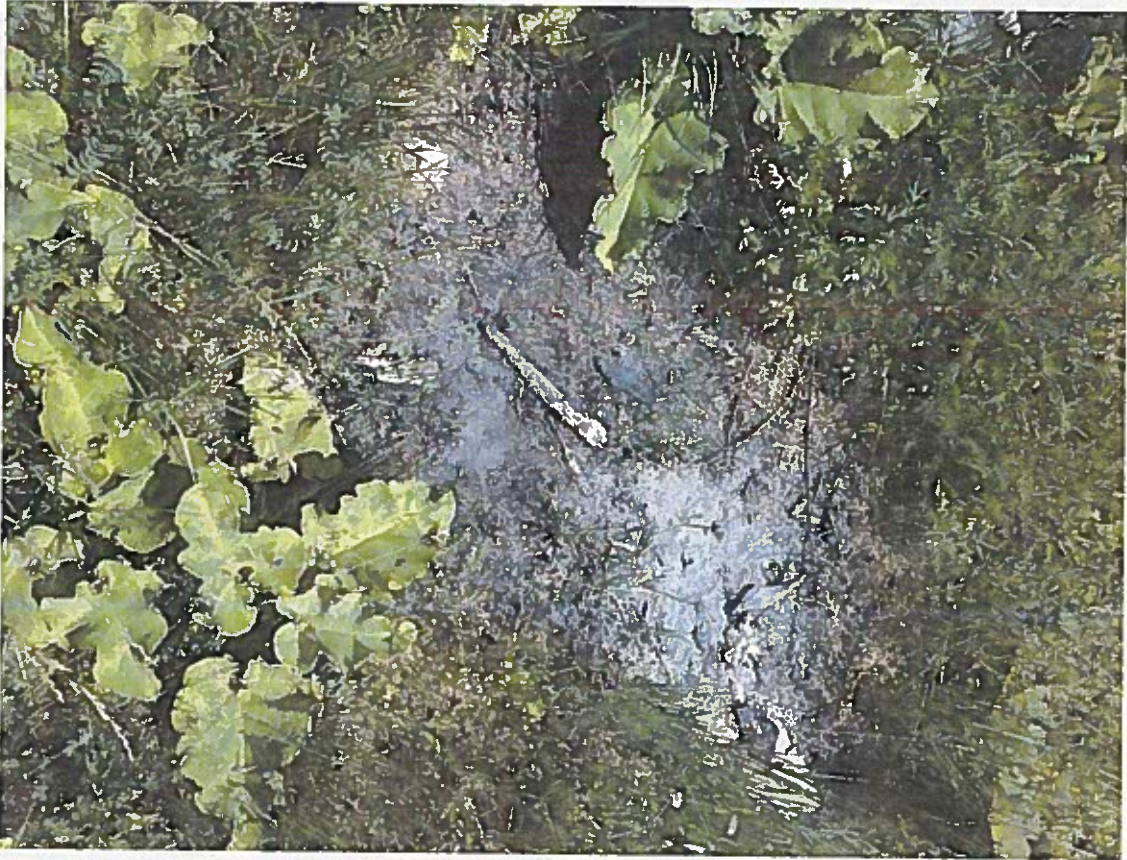
Large burn mark in the ground adjacent to the rear white shed.
